TRU·WATTS

**Power Quality
Assessment Report
&
Proposal**
for

Friday, September 15, 2023

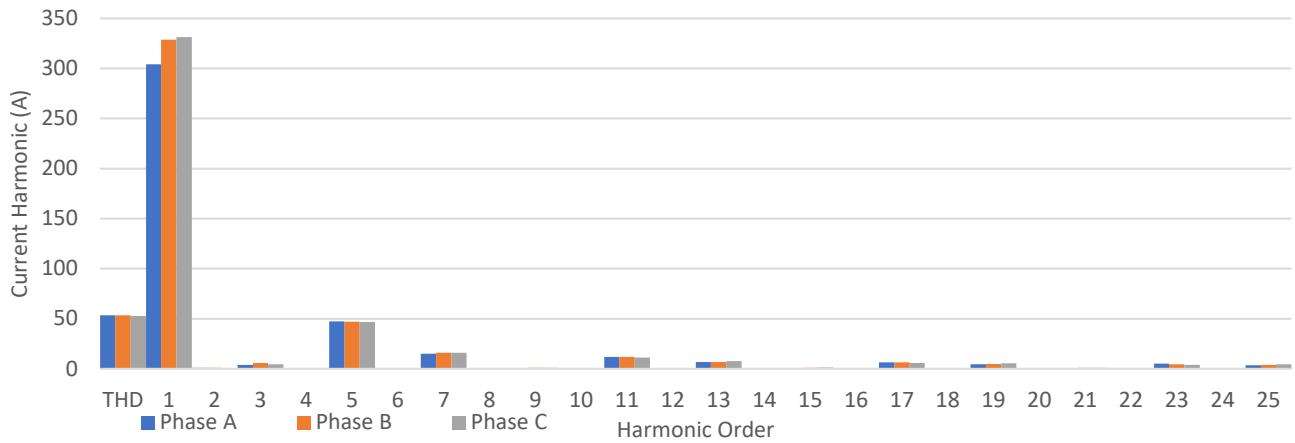
As you can see, the 5th, 7th, 11th, 13th, 17th, 19th, 23rd and 25th harmonic is high relative to the other voltage harmonics. Having high voltage harmonics can cause extra load consumption since the peak voltage with harmonics will be greater. Another common harmonic issue is that it will cause voltage unbalance between the phases. The motor's life span will reduce as a result due to either overloading or irregular voltage signals.

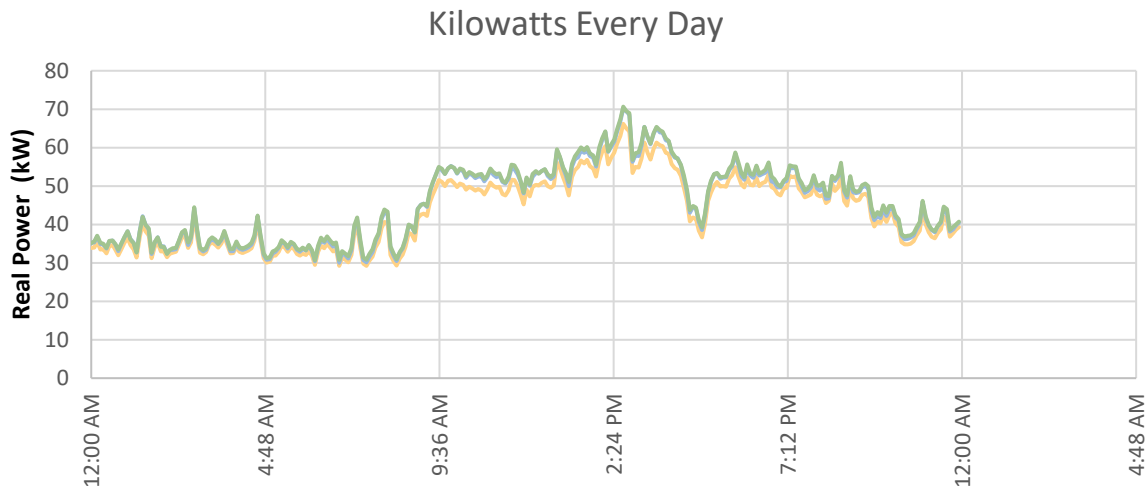
The kW consumed every hour is averaged to be 118 kWh. This is an energy value drawn from the load of the system. However, this value also includes the inefficient energy drawn due to losses and harmonics. Suppose kW is an amount of water and the load is drawing that water from a source, if there are leaks within the pipes or turbulence affecting the current, the efficiency of the system decreases. The importance of power quality is that it could increase the efficiency of the system and reduce unnecessary losses within the system.

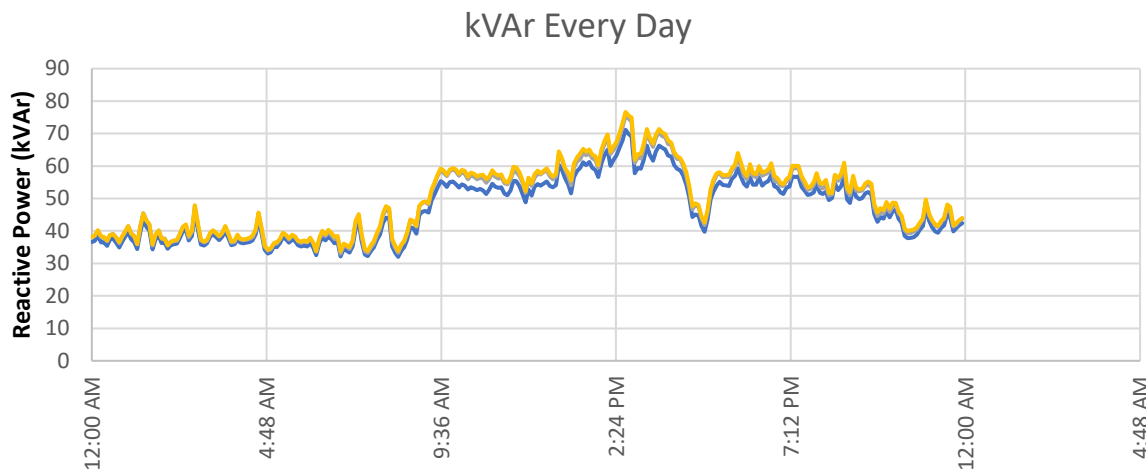
The total kVAr absorbed or returned by the load is 25 kVAr. This value represents the total power absorbed by the load or returned to the utility. To understand reactive power more clearly, let's first establish the relationship between reactance and reactive power. Reactive power is directly proportional to reactance with the current being the proportionality constant. If we lower the reactance of the load, we can lower the kVAr of the load as well. Later in the Power Factor section, we'll discuss the importance of reducing this value.

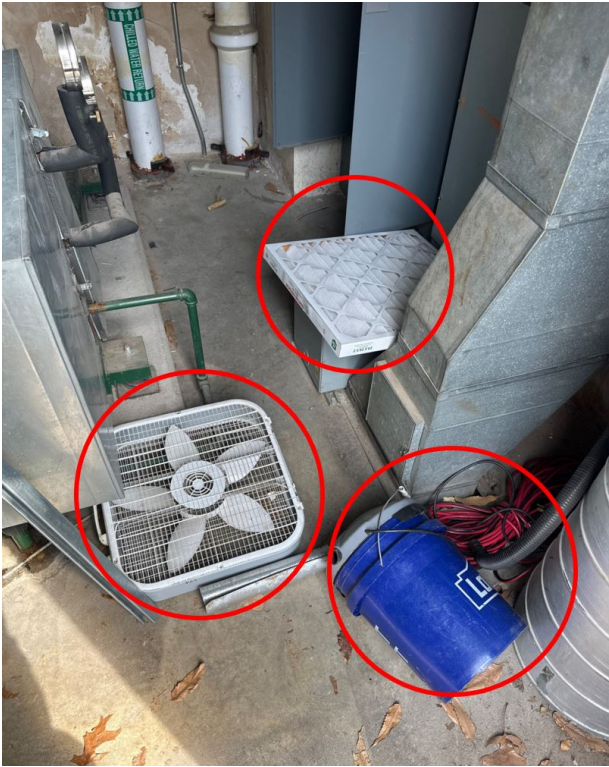
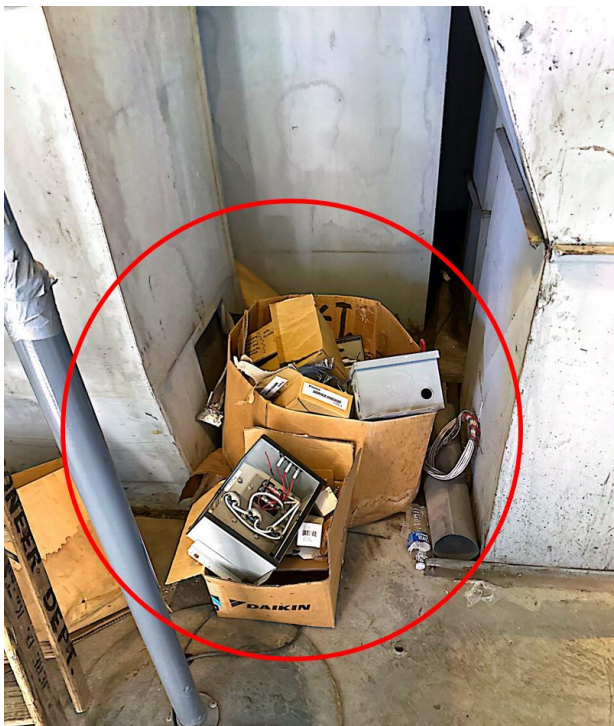
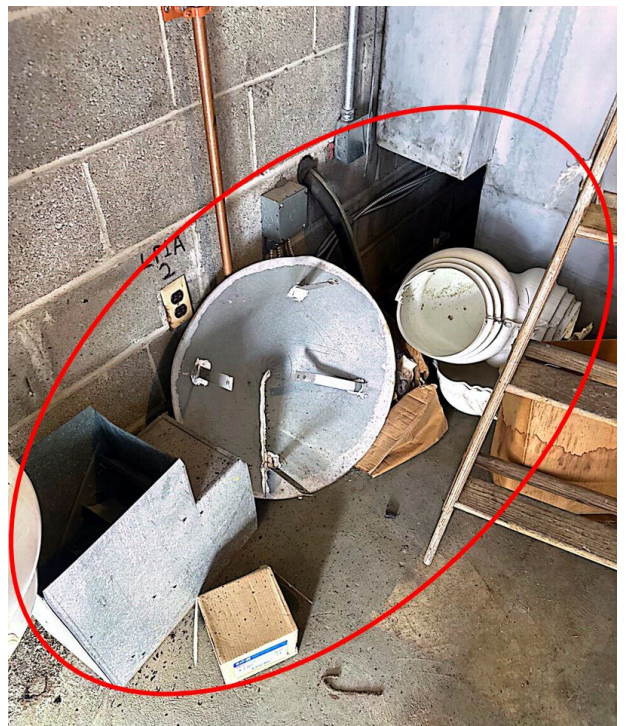
Rooftop Electrical Room housing [REDACTED]:

We noticed debris and obstructions to a safe working environment within the rooftop electrical room housing the [REDACTED]. The working space in the area is concerning and we recommend following the National Electrical Code's (NEC) NFPA 70 which is the benchmark for safe electrical design, installation, and inspection to protect people and property from electrical hazards.

As you can see in the images below, unwanted clutter that obstructs the exit was found. These objects should not be placed in the electrical room and may violate NFPA 70 Article 110.26.

We recommend following both the NFPA 70 and NFPA 70B for safety in the electrical work space. Especially for ■■■■, should an inspector inspect that particular electrical room, they may find it in violation with the cited NFPA 70 Article 110.26.

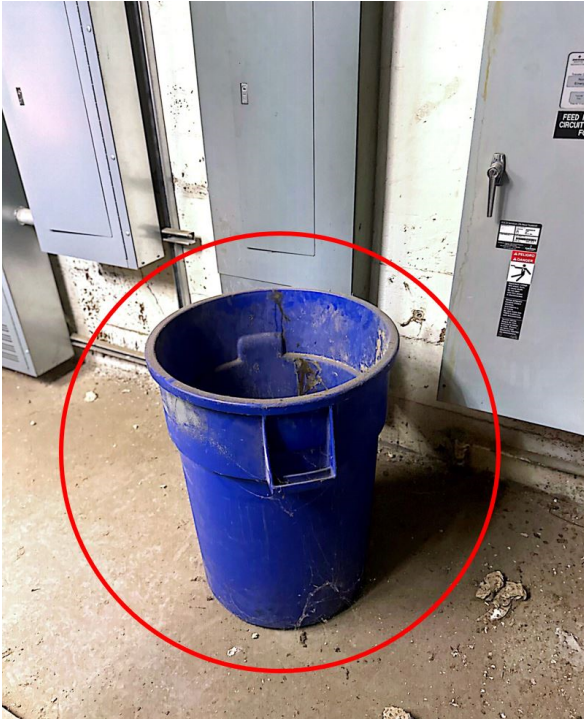
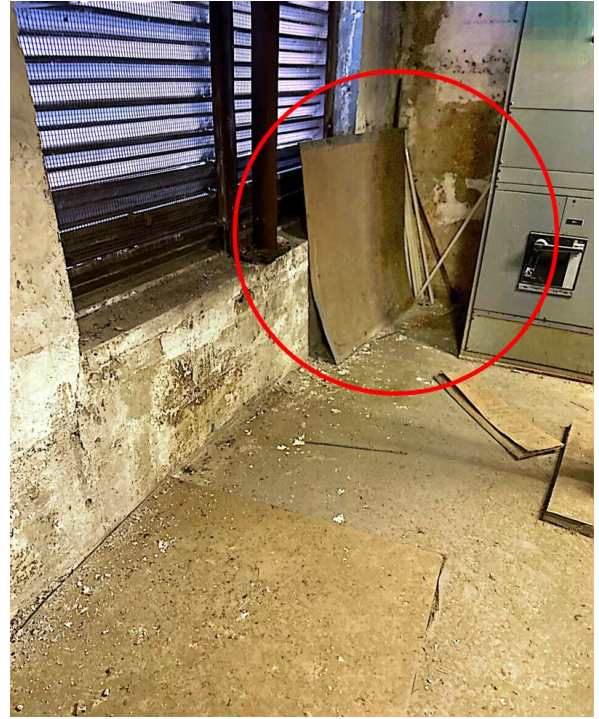
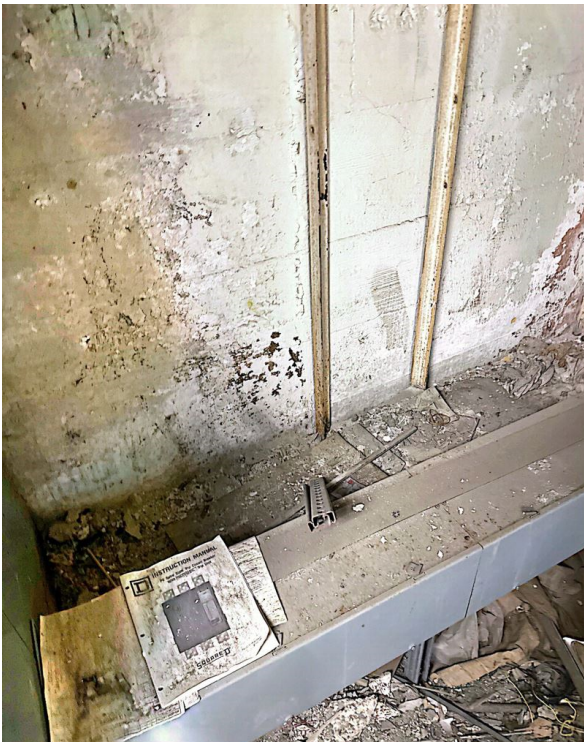
Main Electrical Room (MDP):

As you can see in the image below, unwanted clutter and dust is present in the electrical work space.

In the Main Electrical Room, certain objects should be cleared from the room due to safety risks. We also recommend following the NFPA 70B: Standard for Electrical Equipment Maintenance. We noticed debris and dust accumulating in the room with a potential ventilation issue. For safety, the Main Electrical Room should be cleaned annually and should not be used as storage for anything else. Images will be provided in Survey Images.

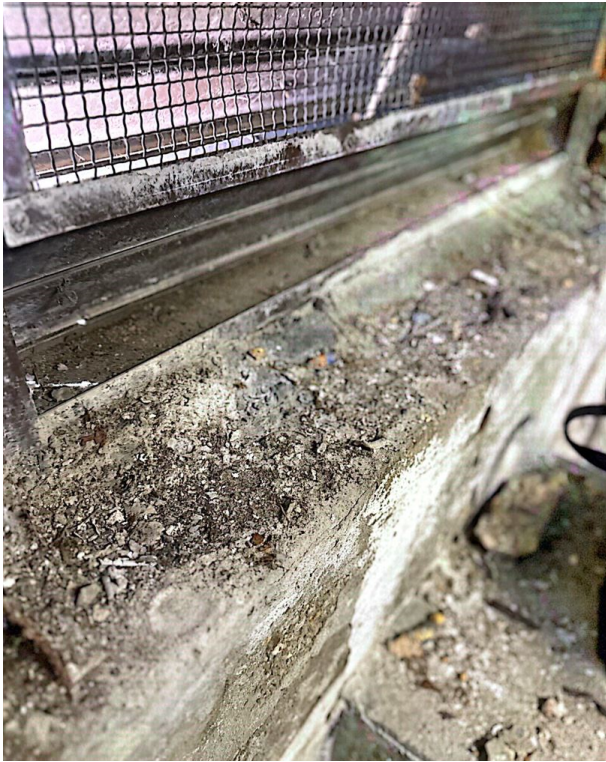
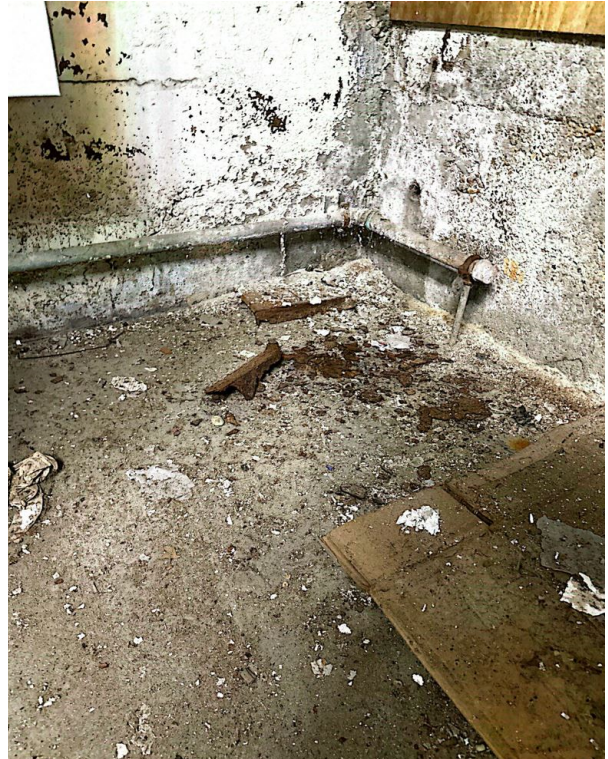
Main Electrical Room (MDP):

As you can see in the image below, unwanted clutter and dust is present in the electrical work space.
